RISK FACTOR

Hubert Zey, Koch-Glitsch, USA, asks what plants are really risking when they clean their mist eliminator.

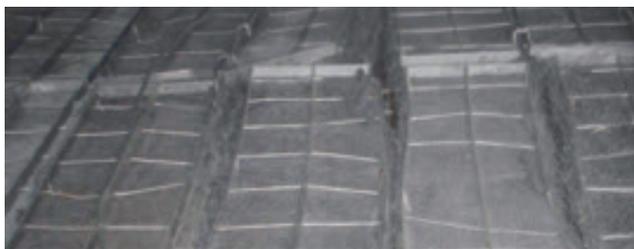
Figure 1. Mesh pad that was removed, cleaned, and no longer retains a proper fit when reinstalled into service, due to the handling and cleaning process.

Another often-overlooked problem when cleaning and replacing the mesh pad is the damage that is done to the used mist eliminator during removal, handling, and reinstallation. When the new pad was built, each section was made slightly oversized to allow compression at the joints and against the vessel wall. Compression from the initial installation does not spring back when the sections are removed, and the additional handling of the mist eliminator during cleaning will add to the problems. The reinstallation does not need to look as bad as that in Figure 1, before there are serious performance problems.

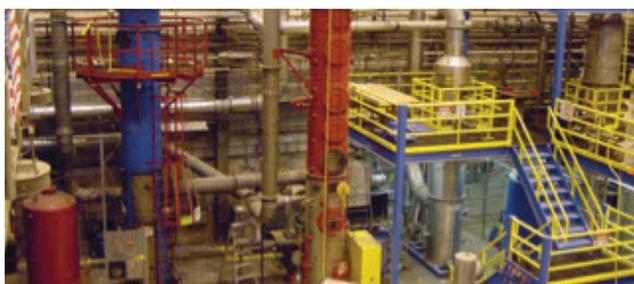
Figure 2. Koch-Glitsch test facility in Wichita, Kansas.

Koch-Glitsch performed a test several years ago to better understand the condition of the reused knitted wire mesh pad. To evaluate the risks, the company obtained a used YORKMESH style 431 pad, which had been removed from an amine absorber during a routine turnaround. Inspection of the mesh pad revealed some moderate solids buildup. Using the normal industry practice, the pad was cleaned with detergent and high-pressure washing. After cleaning, visual inspection showed the mesh pad surface to be similar to that of a new pad. To determine the hydraulic performance, the comparison of the cleaned mesh pad to an identical new DEMISTER® mist eliminator was conducted in the 36 in. (914 mm) dia. test towers at the Koch-Glitsch pilot plant facility in Wichita, Kansas, US (Figure 2).

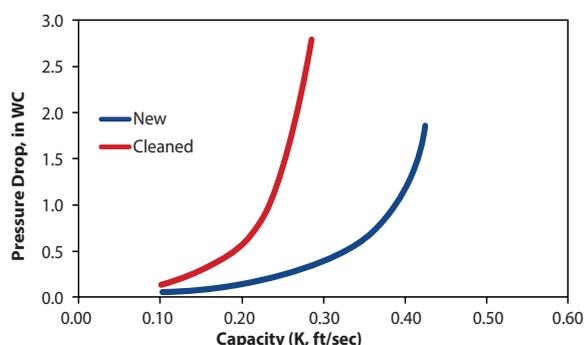
Figure 3. Hydraulic capacity test results show the performance of new versus cleaned mesh. The cleaned mesh was removed from service, cleaned, and reinstalled into pilot plant column for testing.

Although the mesh pads looked similar, testing revealed that the original capacity of the cleaned pad had been reduced by 31% due to solids that remained in the middle of the mesh pad. In addition, wire surface corrosion roughened the originally smooth wire surfaces, which increased the liquid holdup in the mesh, leading to further reduction in capacity. Performance tests showed that the cleaned mesh pad capacity at flooding was now 15% below the traditionally used design K-factor of 0.35 ft/sec. (0.106 m/sec.) (Figure 3).

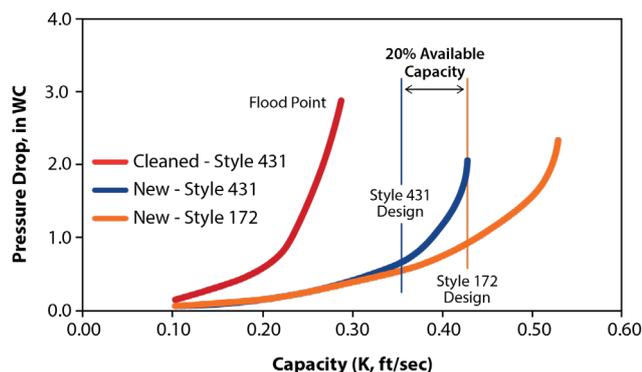
Figure 4. Hydraulic capacity test results show the benefit of using high capacity mesh to replace traditional style mesh.

If nothing changes in the process, the traditional style 431 may get the plant to its next turnaround; however, using a YORKMESH knitted mesh style 172 can increase capacity by 20% over the traditional style 431 pad. The extra capacity may not be needed immediately, but the extra capacity can be critical when fouling starts to reduce the available safety factor. As shown in Figure 4, using the style 172 knitted mesh mist eliminator shifts the dangerous re-entrainment point much further from a plant's operating rates.
